# DAM INSPECTION CHECKLIST POSSUM POINT POWER STATION POND ABC

INSPECTION DATE: APRIL 6, 2016

INSPECTED BY: K. ACRE

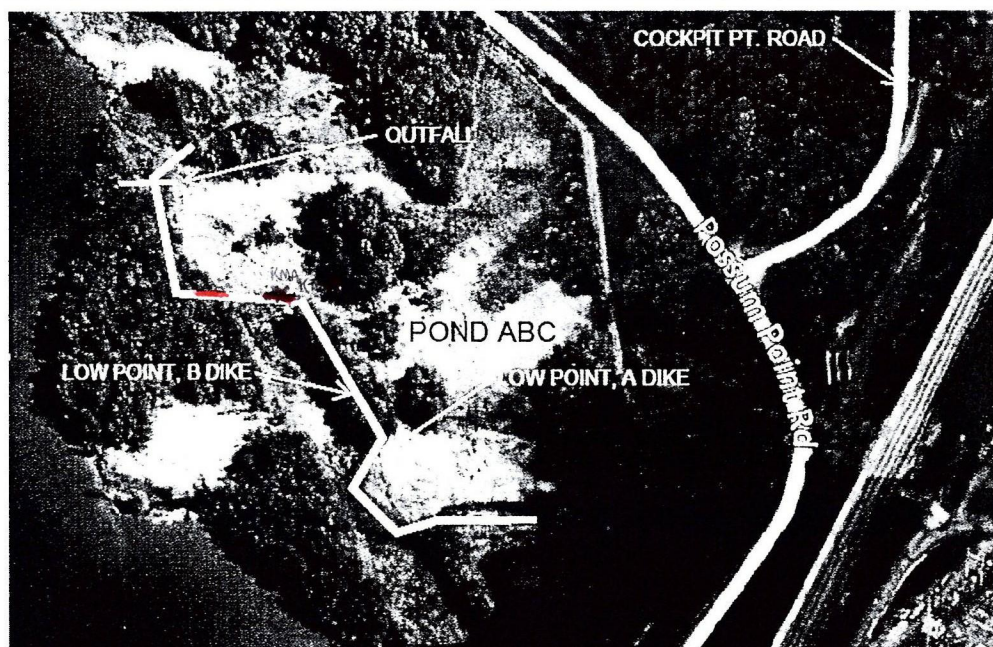
Location/ Condition	(y/n)	Change (y/n)	Comments
Low Point, A dike*			
Flow	N	N	10:38 → SAND BAGS & RIBBON ARE IN PLACE, AND THERE IS NO STANDING WATER AGAINST SAND BAGS.
Erosion	N	N	SEVERAL BAGS ARE RIPPED.
Low Point, B dike*			
Flow	N	N	10:41 → SANDS BAGS ARE IN PLACE AND THERE IS NO STANDING WATER AGAINST SAND BAGS.
Erosion	N	N	A COUPLE SAND BAGS ARE RIPPED.
Outfall water surface El. (top of stoplogs to water)			10:51 → NO FLOW THROUGH WEIR, NO STANDING WATER AGAINST WEIR, AND WEIR APPEARS TO BE OK.

**Additional Comments (Note any changes observed along the embankment crest or downstream slope observed from the crest.):** LOW POINT, C DIKE: 10:49 → SAND BAGS ARE IN PLACE AND THERE IS NO STANDING WATER AGAINST SAND BAGS, SEVERAL SAND BAGS ARE RIPPED. NO FLOW OR EROSION.

STANDING WATER ALONG TOP OF EMBANKMENT TO POUNDS (SEE FIGURE BELOW).
